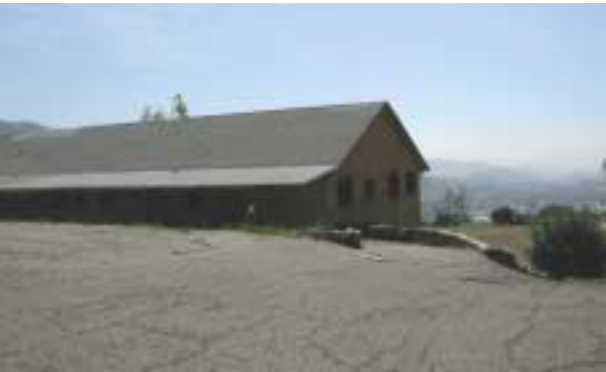
Figure 1. Existing conditions at RPLA site, looking south

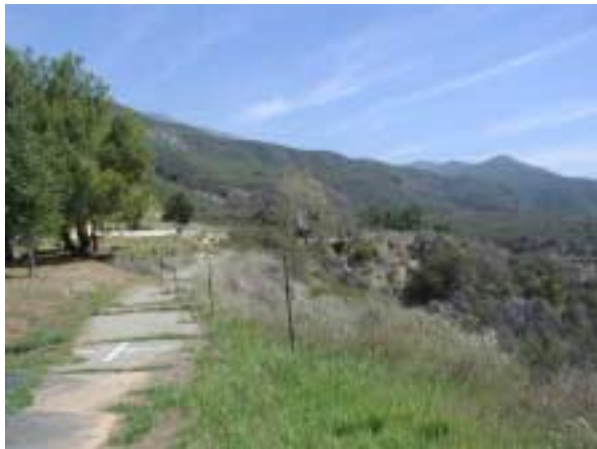
Figure 2. South boundary of RPLA, looking east. Drainage off-site is to canyons and slopes like the one to the right.

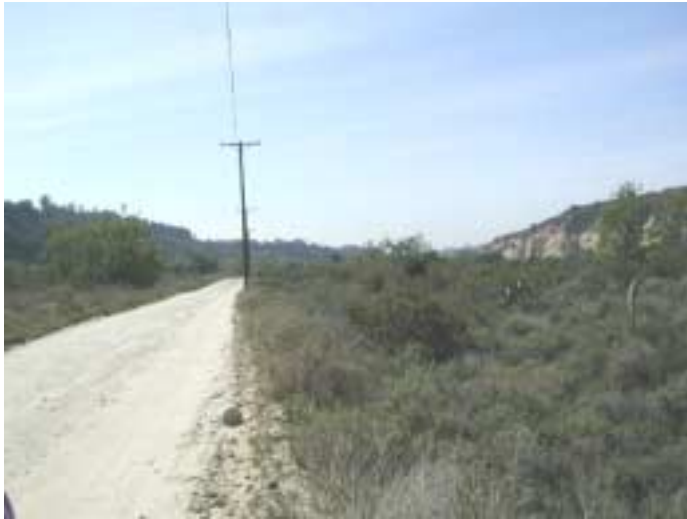
Figure 3. Looking west (downstream) along current Trabuco Creek Road and site of new lower access road. Creek channel to the right.

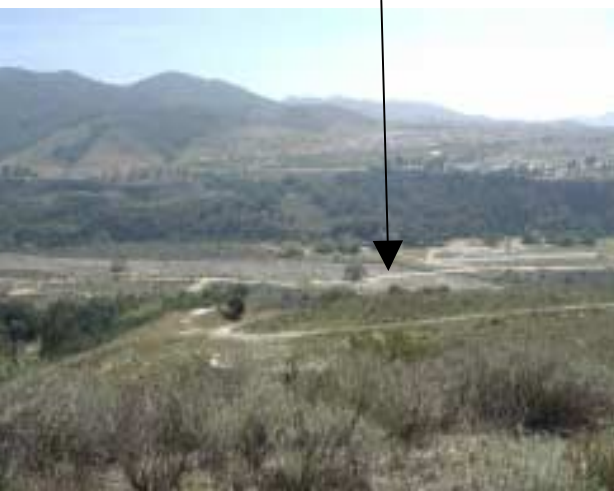
Figure 4. View south of Arroyo Trabuco from RPLA site. Existing crossing.

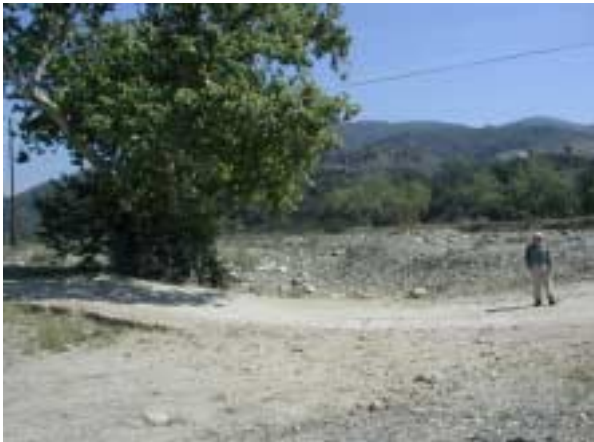
Figure 5. Looking upstream at site of current creek crossing and proposed culvert location.

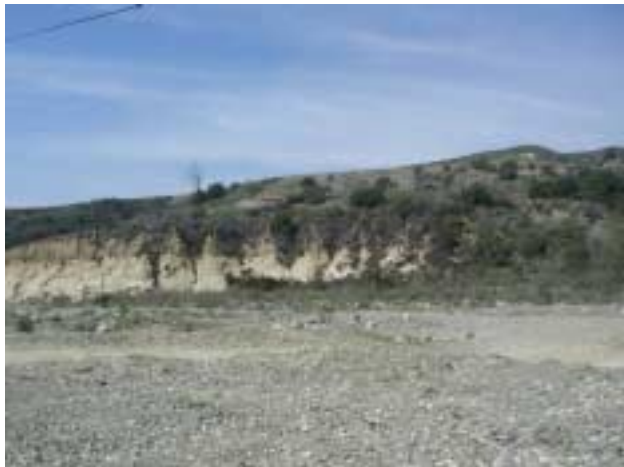
Figure 6. Looking downstream from low point of crossing. North floodplain is constricted by cliffs. Upper access road will traverse hillside to the right.
